# ACCIDENT AND INCIDENT REPORT

202 [REDACTED] Tesla Cybertruck  
VIN # [REDACTED]  
Policy No. [REDACTED]

# **GEICO LIABILITY CHALLENGE**

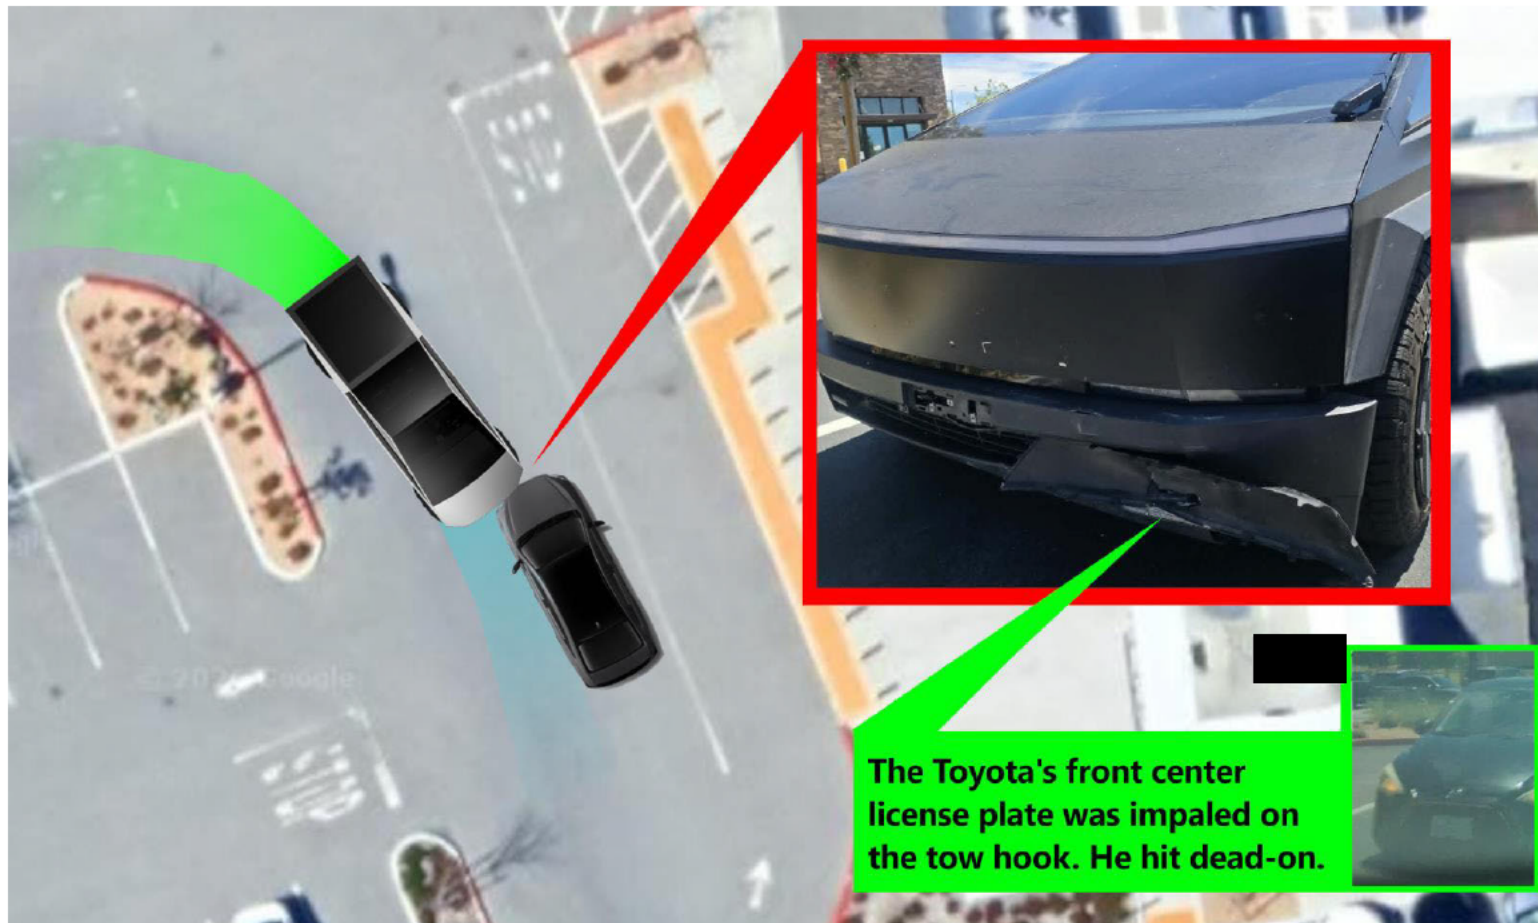
The Toyota's front center license plate was impaled on the tow hook. He hit dead-on.

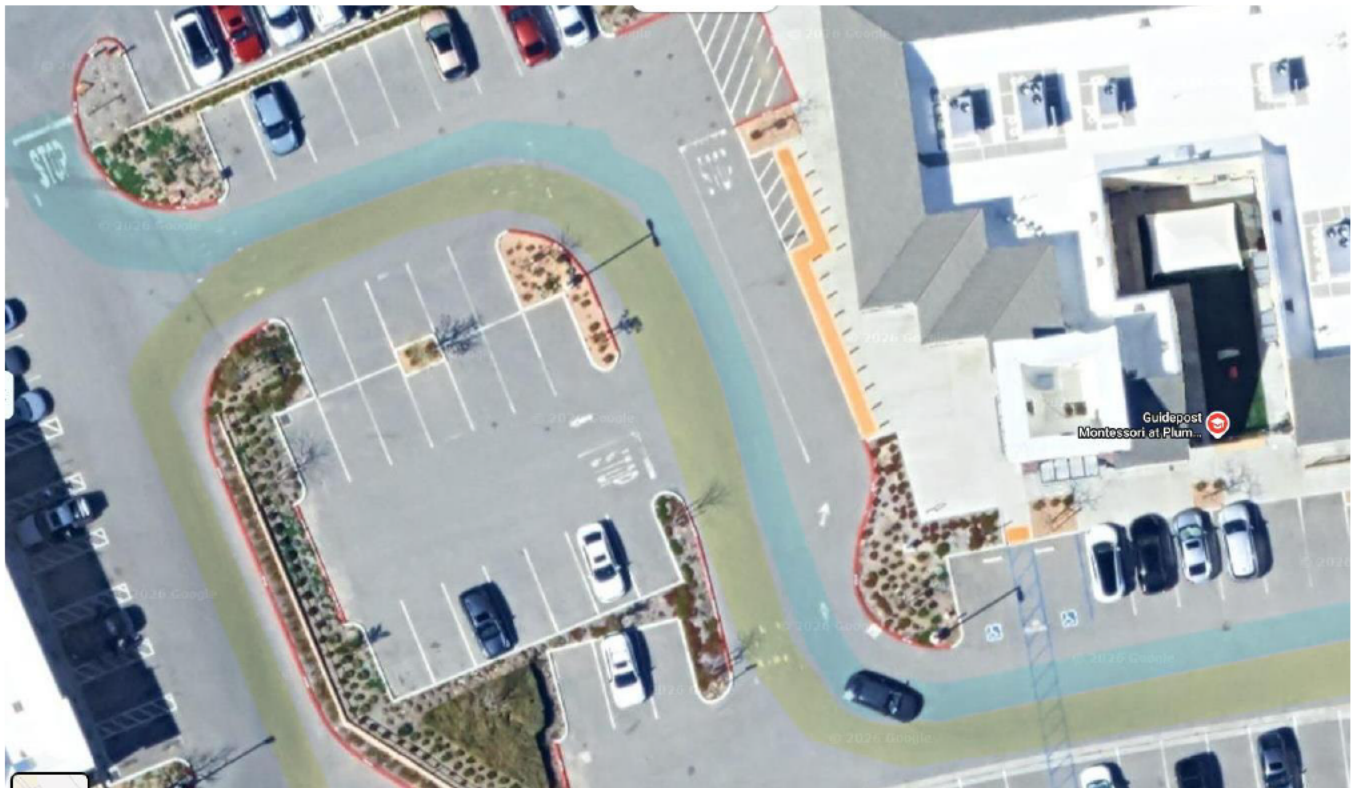
Color enhanced – yellow is normal vehicle travel, **blue** is improper vehicle travel from the Toyota who was required by law and by design to keep right.

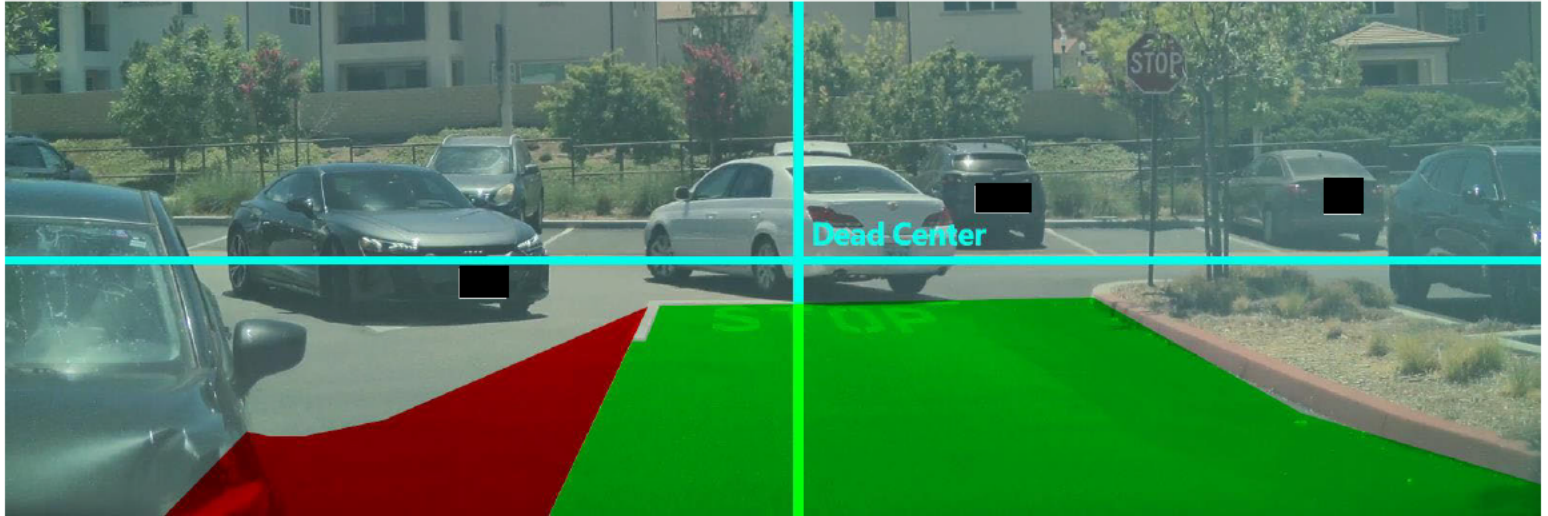
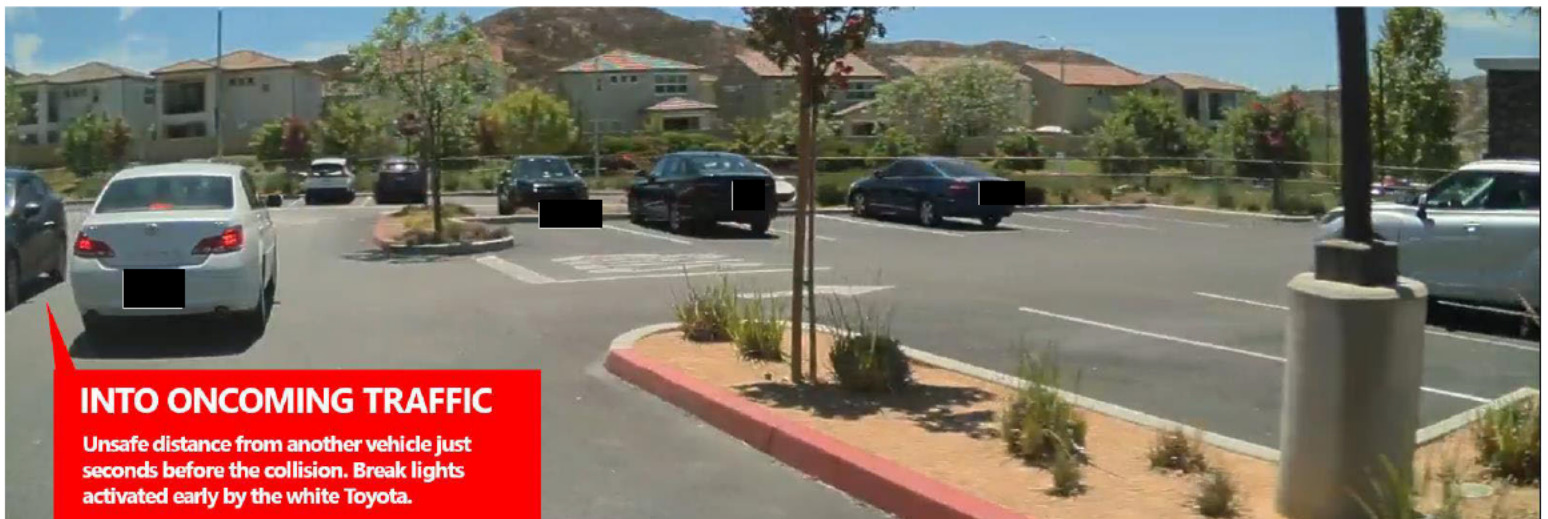
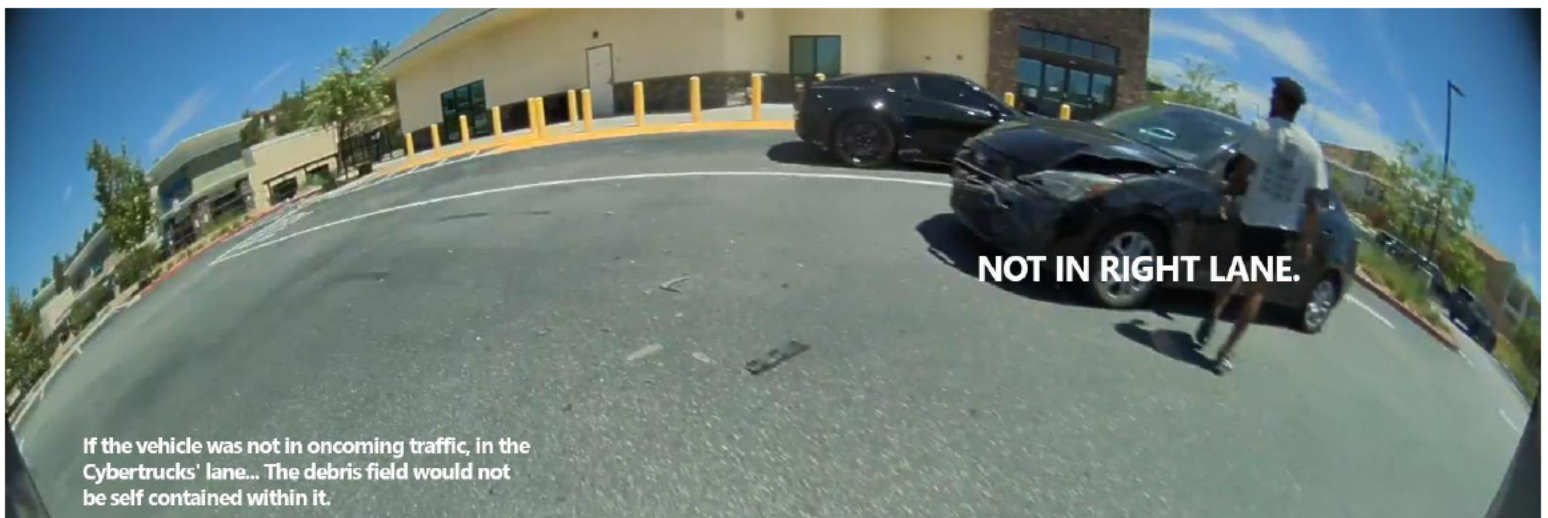
At the point of impact, once it's turn was complete the cybertruck was in it's lane with dead center pointing in the very middle of the lane.

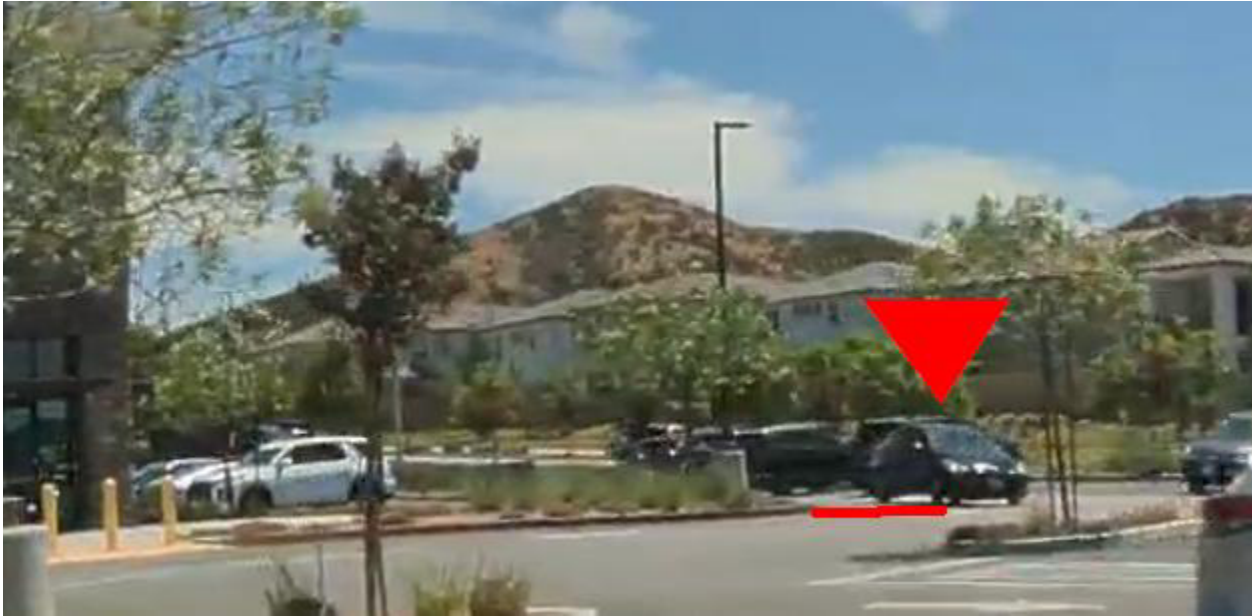
1. At precisely the same time, both the Cybertruck and the Toyota were rounding their respective corners.
2. The Toyota was travelling at a higher rate of speed and left a considerable right-tire gap from the corner.

3. This gap likely contributed to the incident.
4. The Toyota as it turned experienced full axial tilt on it's left side, indicating the driver had oversteered and overcorrected the turn **due to increased speed and poor handling**:

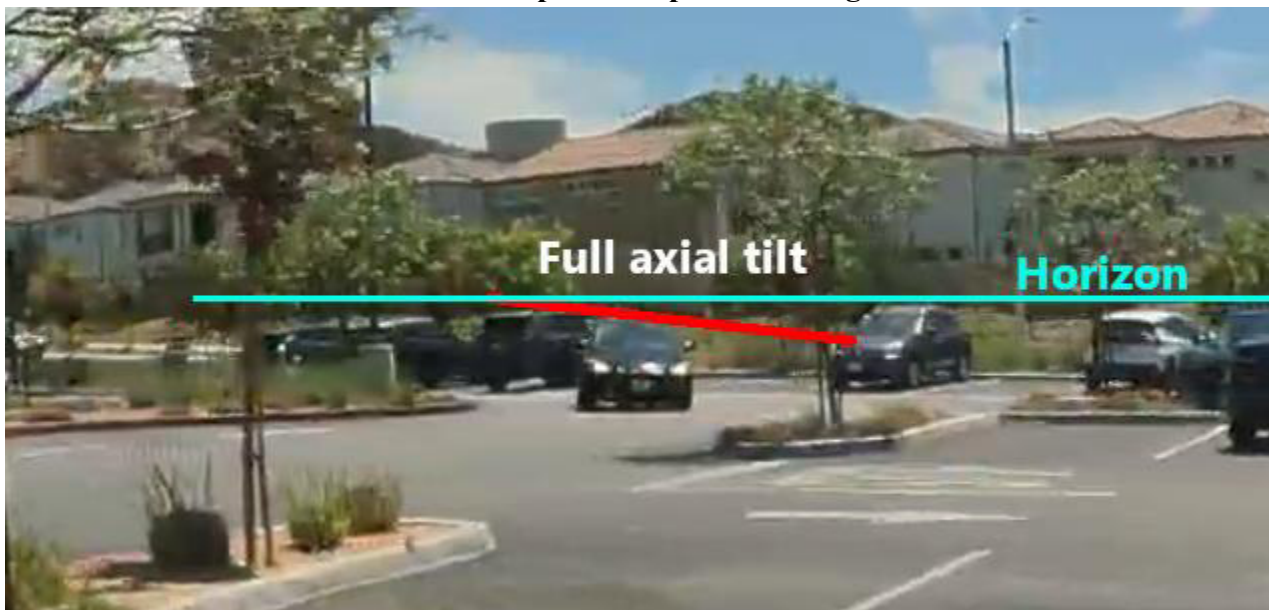
5. The other parties' Toyota had rounded the corner and made an erratic "snap" motion to the steering wheel; causing significant lateral force; indicating any of the following:
  - a. He may not have been paying attention or;
  - b. He may have been distracted while turning the corner or;
  - c. He may have seen the arrow on the ground indicating he must remain in the right lane but had become unsure.
6. Either way, the overcorrection resulted in extreme body roll. The Toyota was not just dealing with one isolated car pulling out; they were approaching an active, established stream of moving traffic following a uniform path.

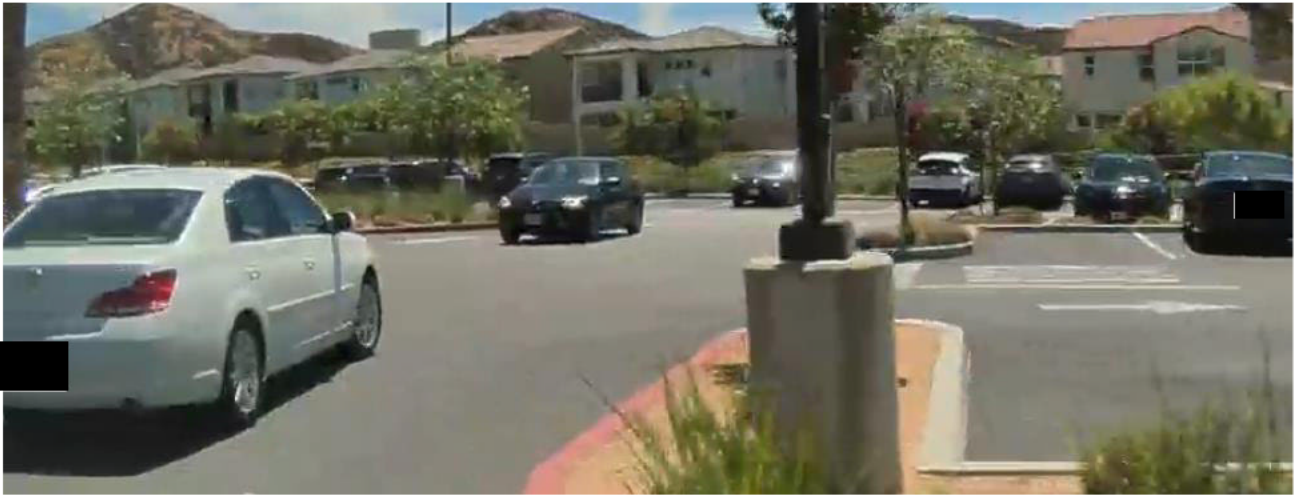
7. As the Toyota approached forward, it came close to colliding with the white Toyota in front of the Cybertruck:

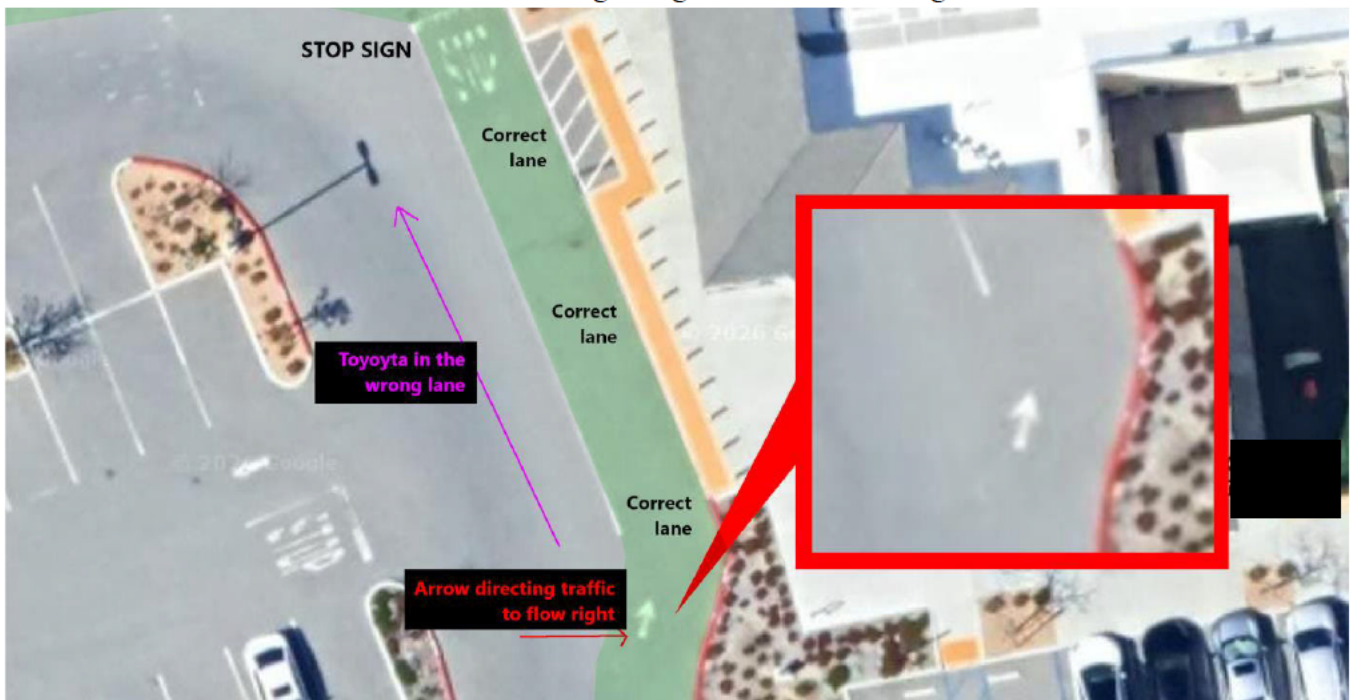
8. Problematically for the Toyota, they were not in the correct lane. They were travelling forward into oncoming traffic.
9. An arrow is painted which clearly notifies turning traffic to remain to the right and into a lane. The black Toyota did not do that and rather maintained a heading straight on into oncoming traffic.

There are only two lanes, not three. The demarcation/lane borders are clearly defined. The Toyota instead did not maintain his heading into the right lane as directed by the arrows. He did not keep to the right. Instead he jerked the wheel, decided to not keep to the right and went straight into oncoming traffic **while having an entirely empty lane to his right complete with stop sign and no-passing lines.**

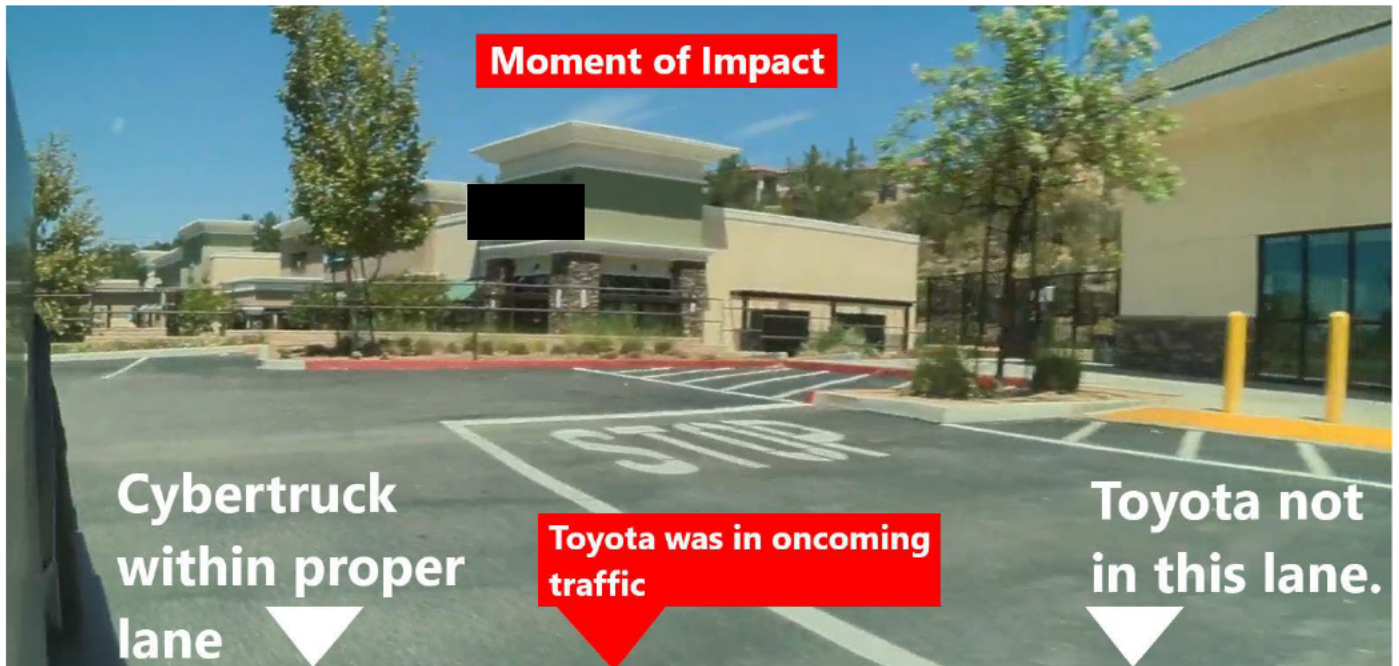
10. At the point of impact, the Cybertruck was well within it's own lane – the Toyota was also in the Cybertruck's lane heading into oncoming traffic when the collision happened.

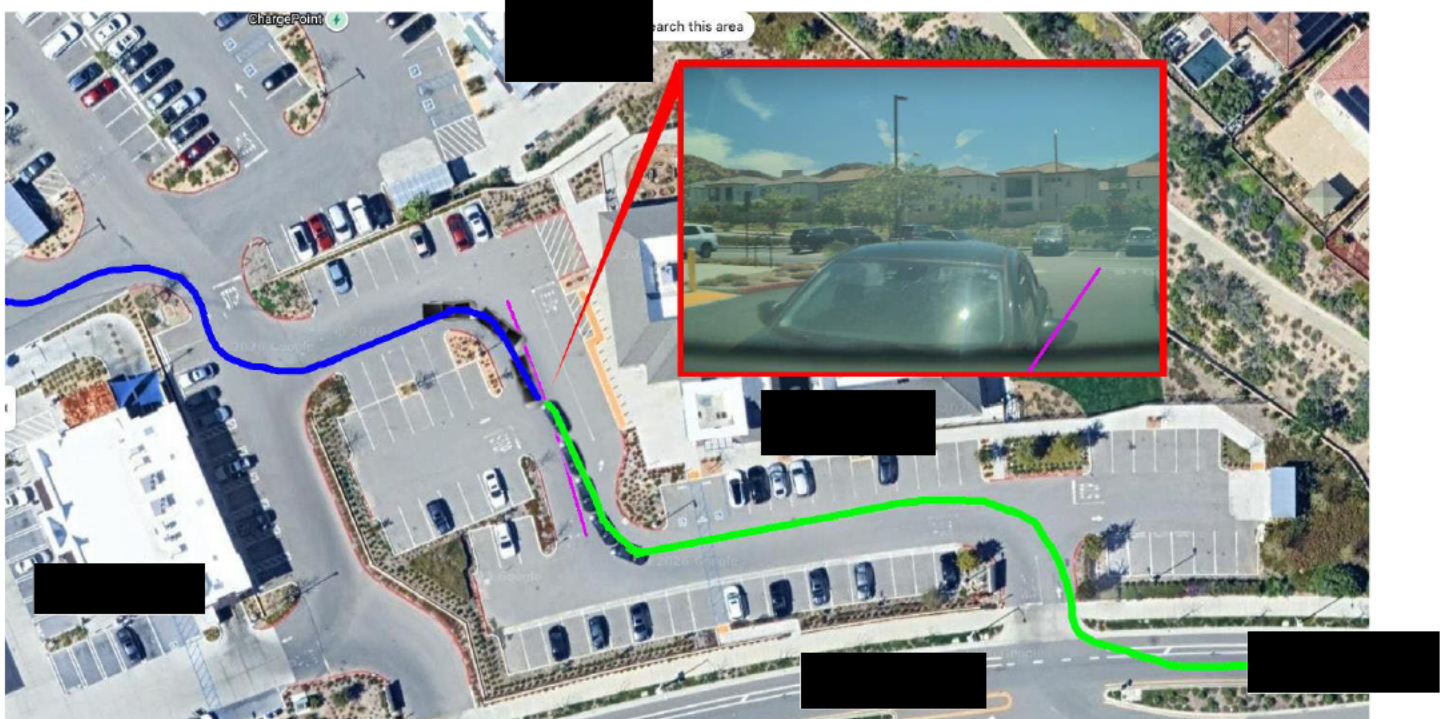
11. It appeared according to the video at the last moment that the Toyota had veered further left into the Cybertruck's direct path.
12. The reconstruction below shows the path both vehicles had taken, accordingly, it shows, that even if an implied lane existed (based off of the painted STOP on the ground, the black vehicle crossed over into the Cybertrucks "safe zone".

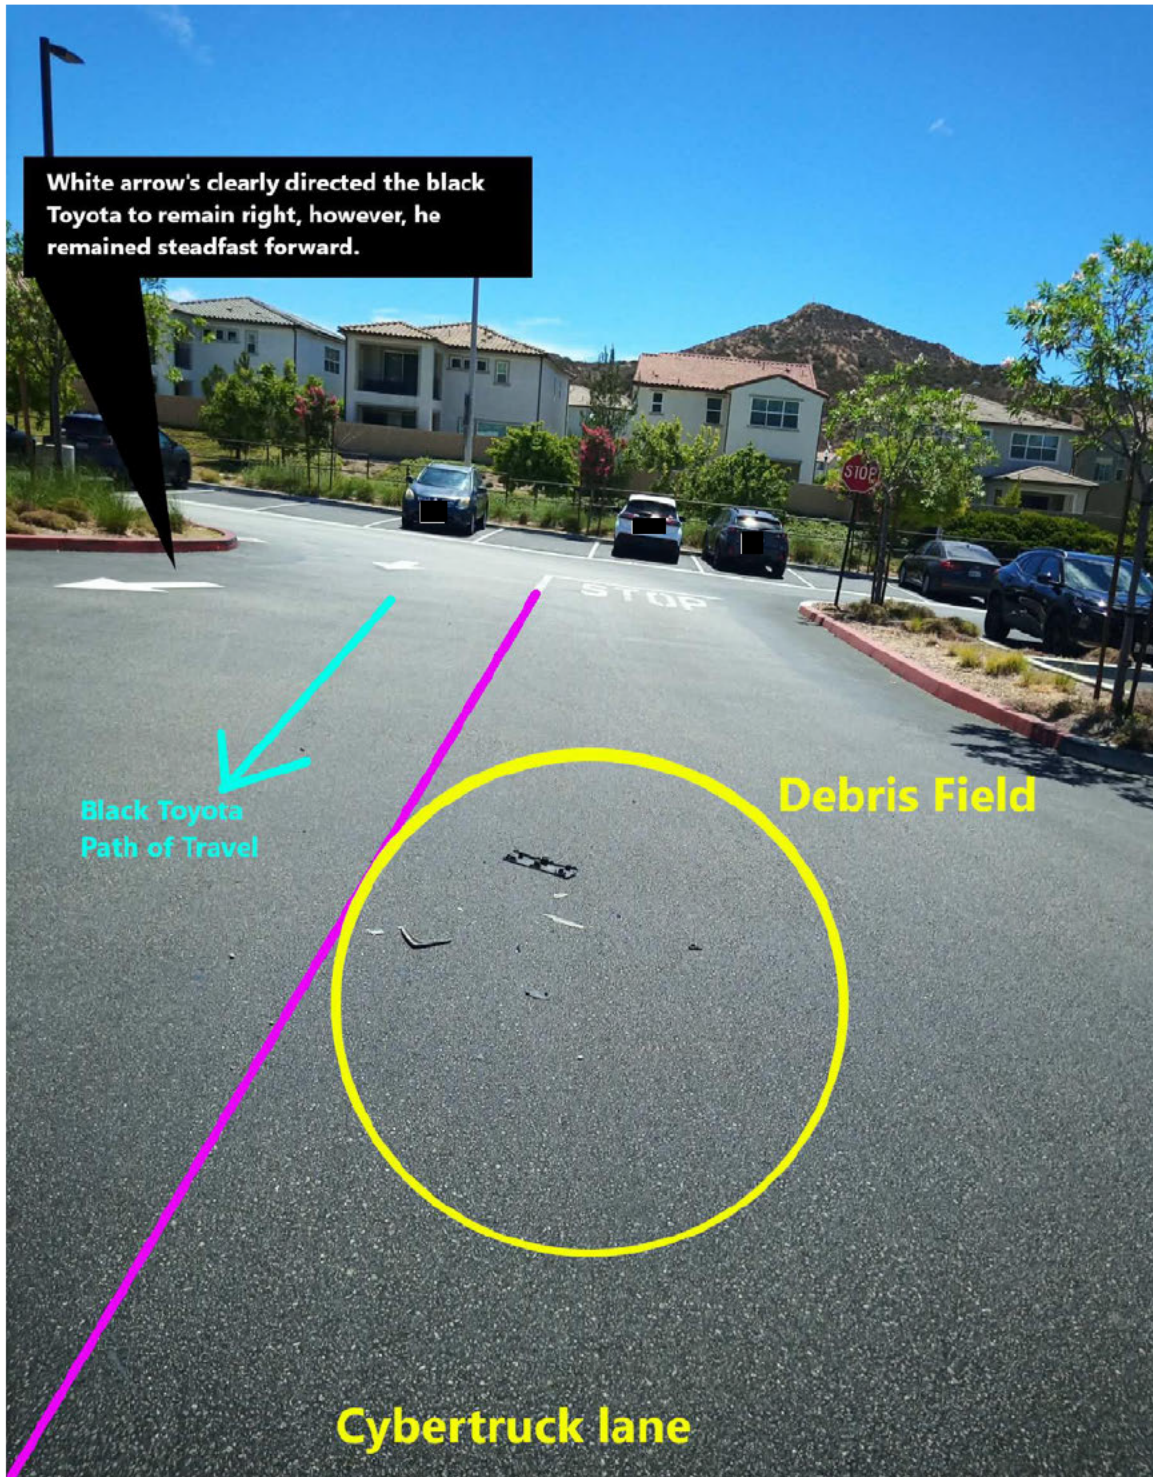
13. The debris field makes it very clear that the collision happened within the Cybertrucks lane, where the Toyota was not allowed to cross over into. Further, as stated, the black Toyota had an obligation to remain the right, not to cross into oncoming traffic to avoid the stop sign at the end of the right lane:
