# ACCIDENT AND INCIDENT REPORT

202 [REDACTED] Tesla Cybertruck  
VIN # [REDACTED]  
Policy No. [REDACTED]

# **GEICO LIABILITY CHALLENGE**

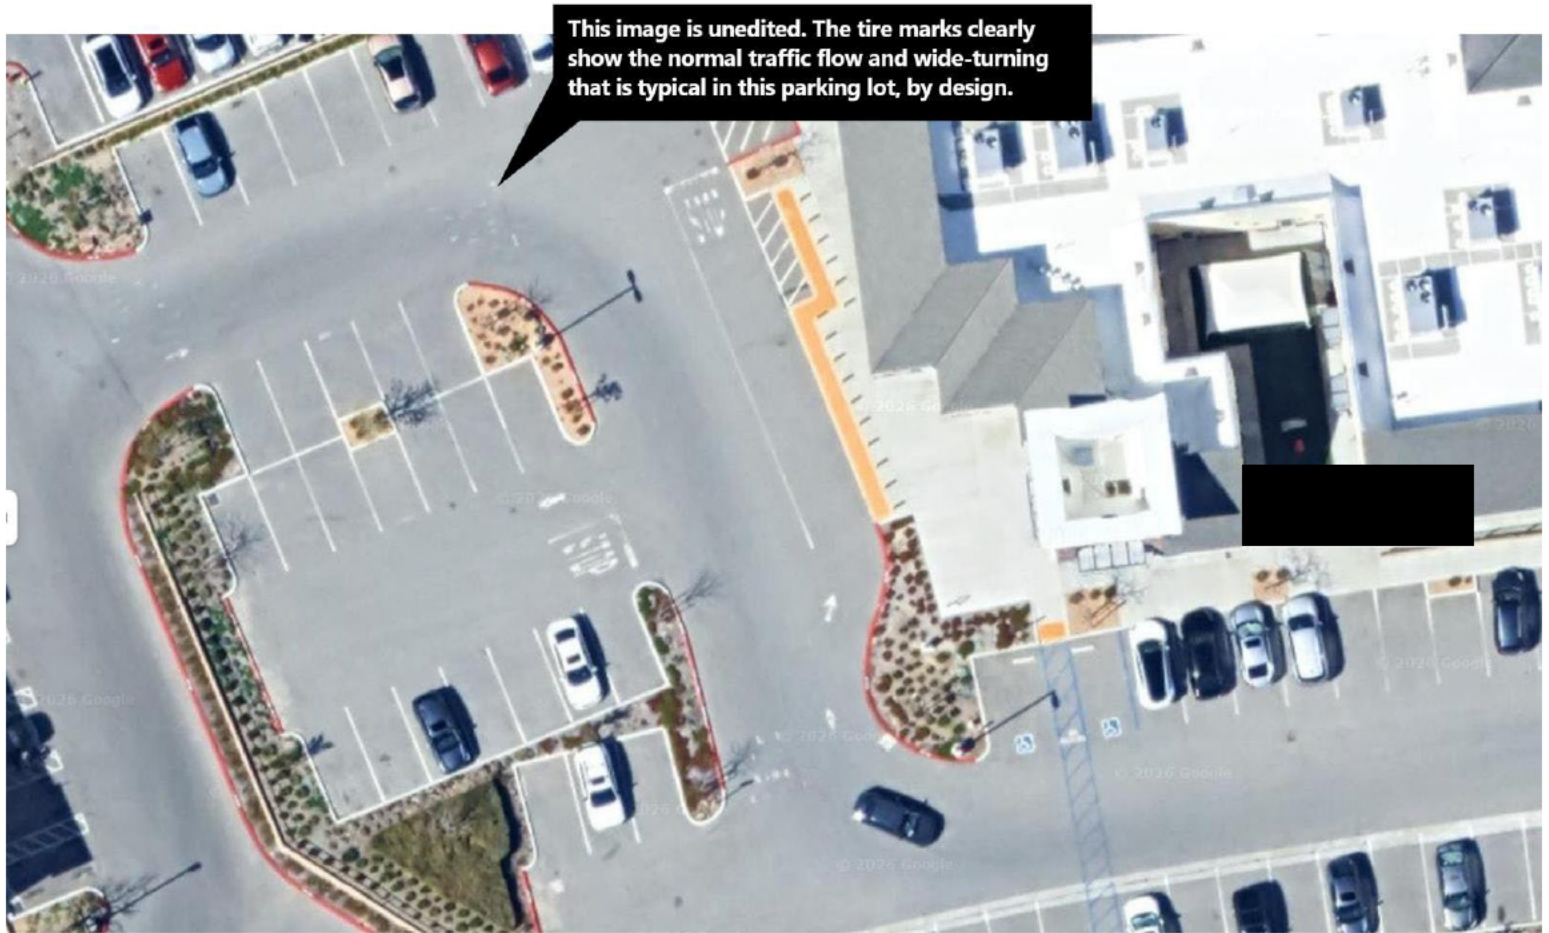
## Overhead Map of Accident Scene

The accident occurred at [REDACTED] in a private parking lot on the corner of [REDACTED] and [REDACTED].

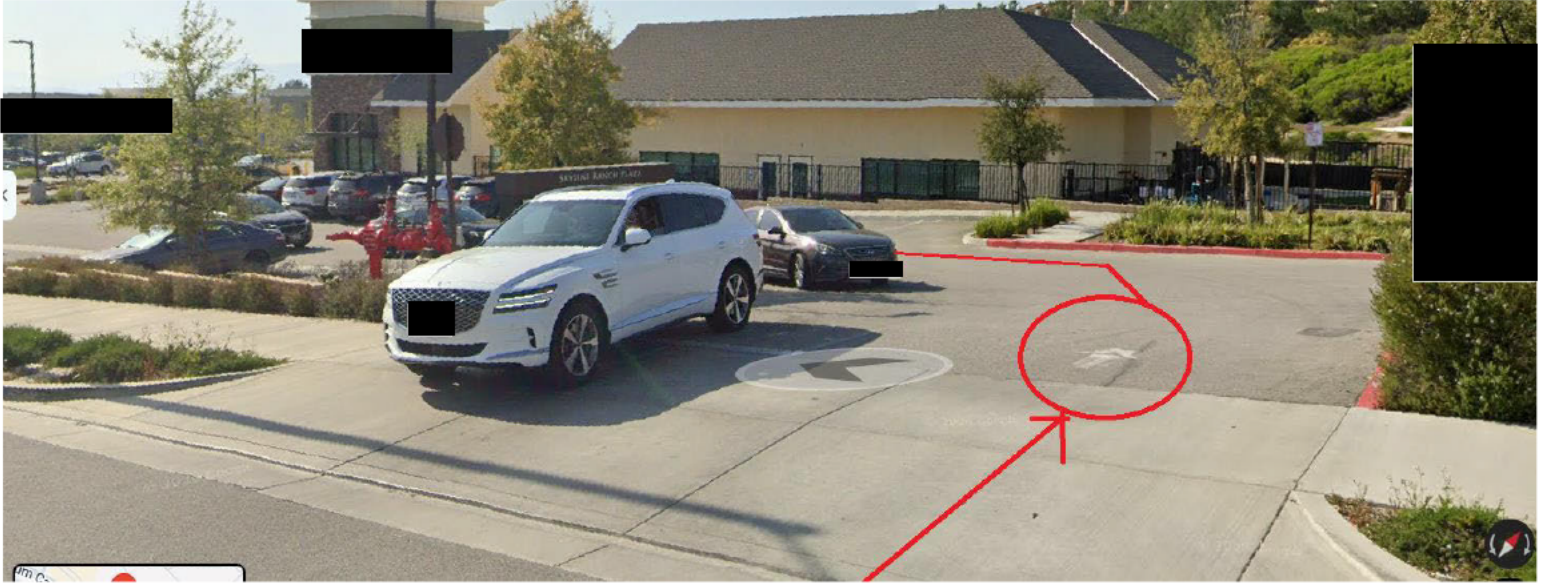
## Traffic Flow Control

From the moment you enter the property, arrows guide the flow of traffic. This exists at all times in the lot.

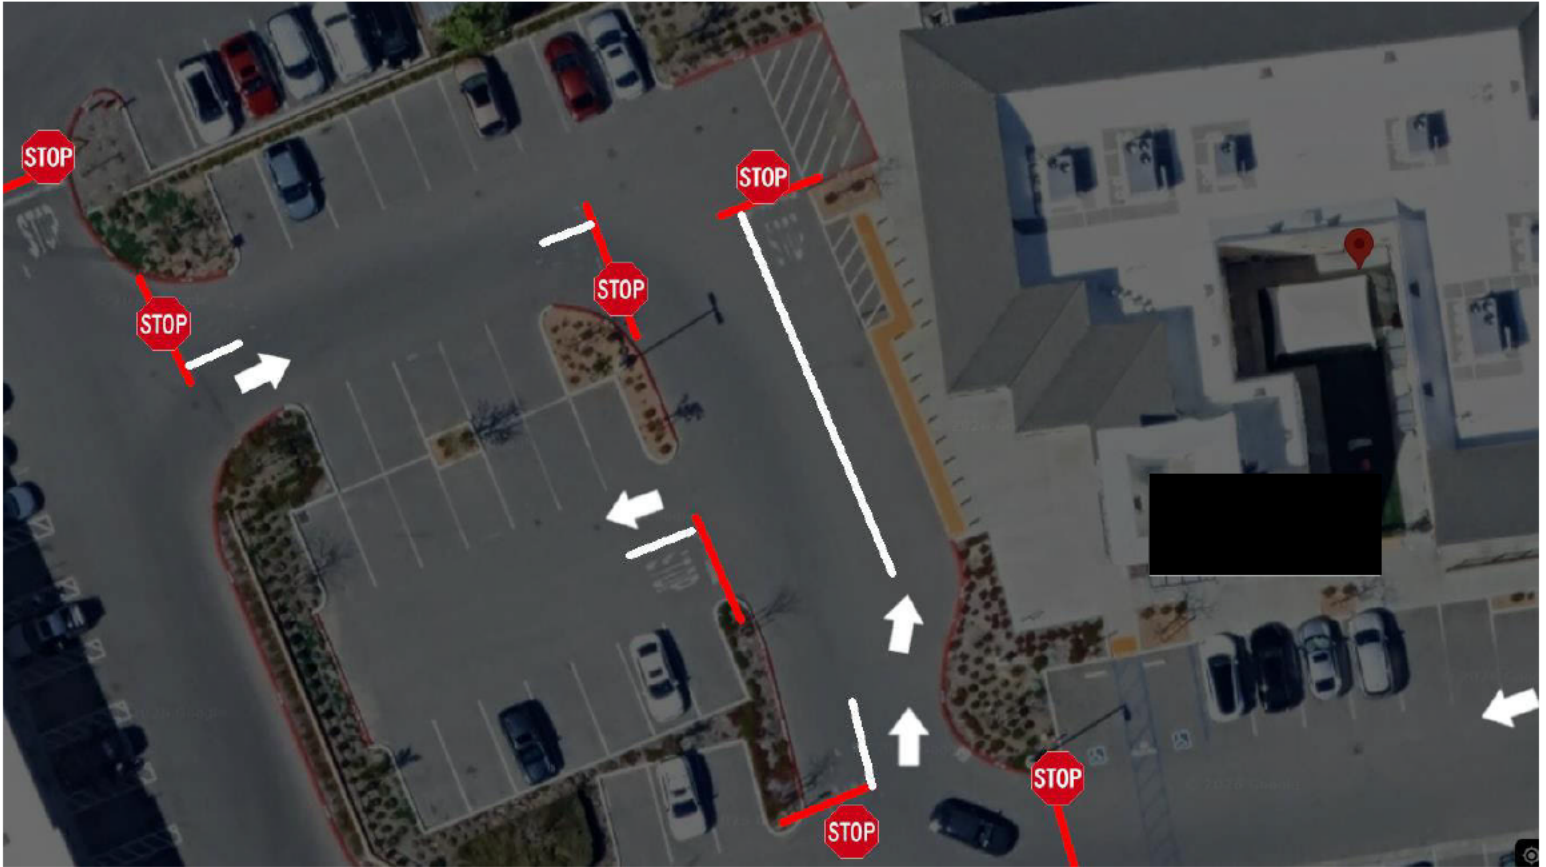
The parking lot itself is entirely engineered for slow moving, careful traffic as this is [REDACTED]. The arrows are not decoration, they are painted on the ground for a specific purpose: control and slow the flow of traffic.

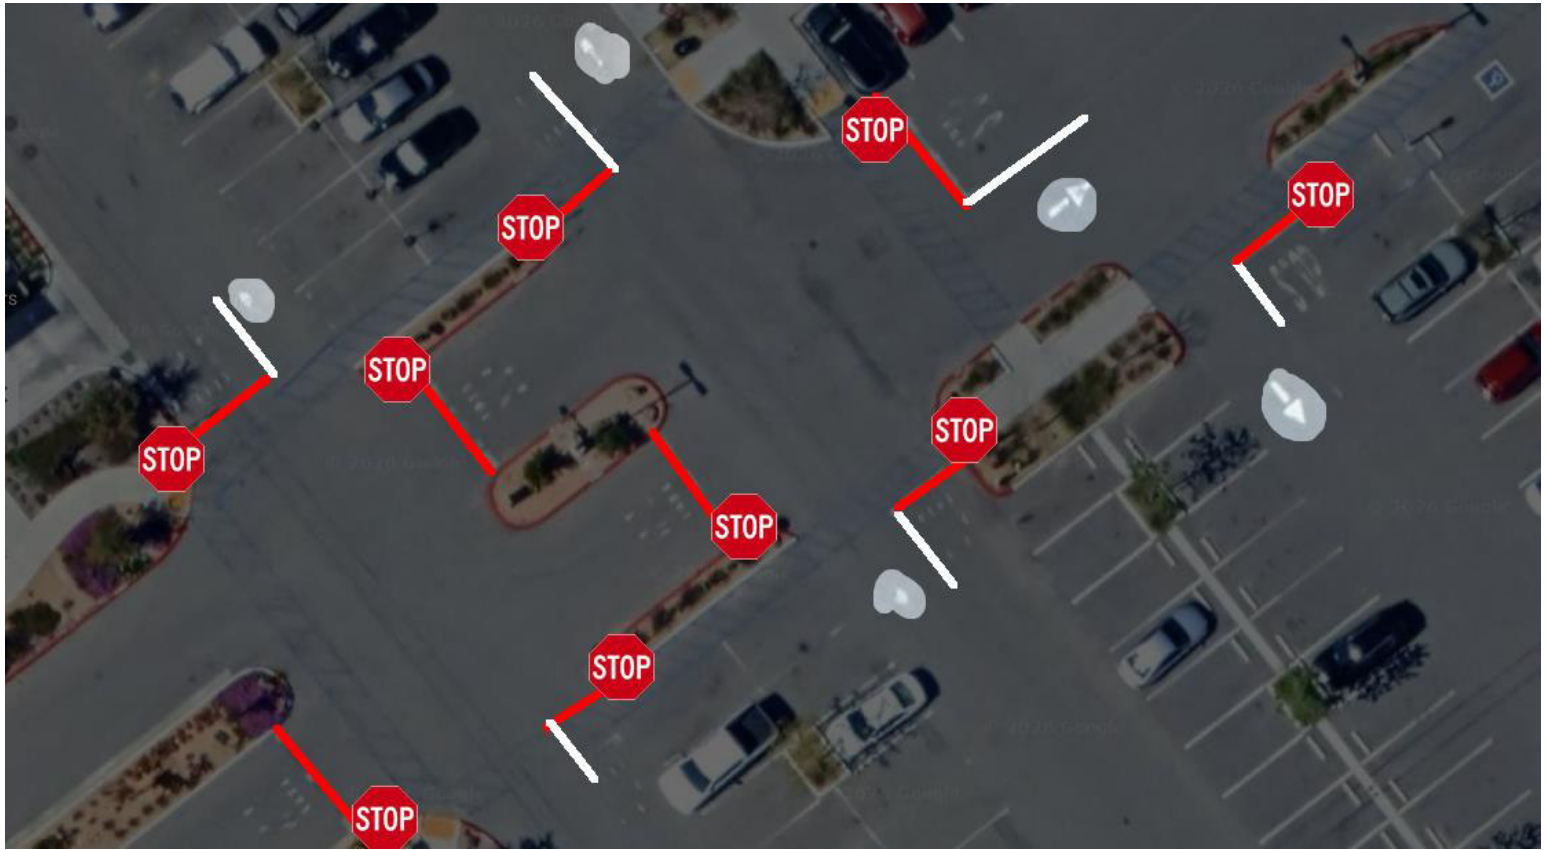
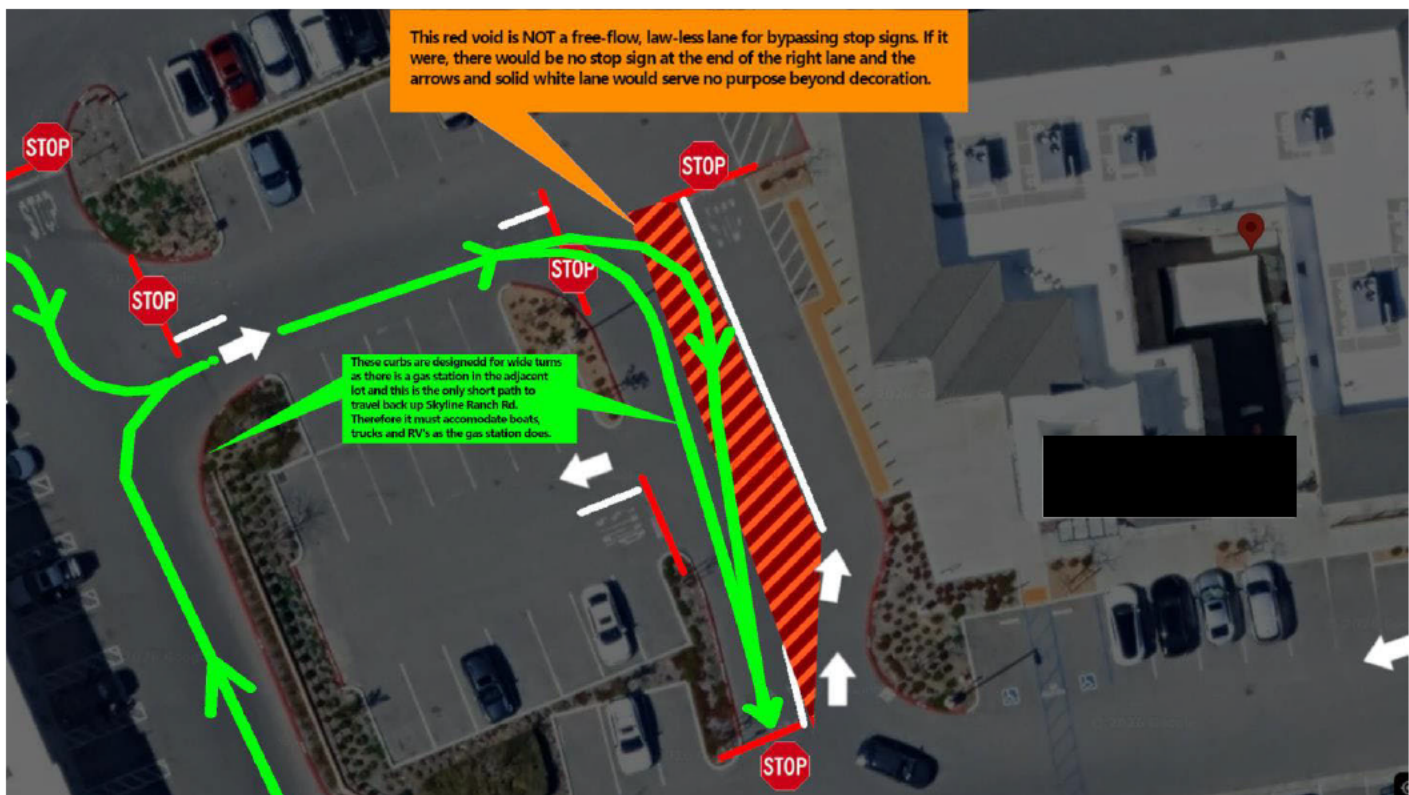
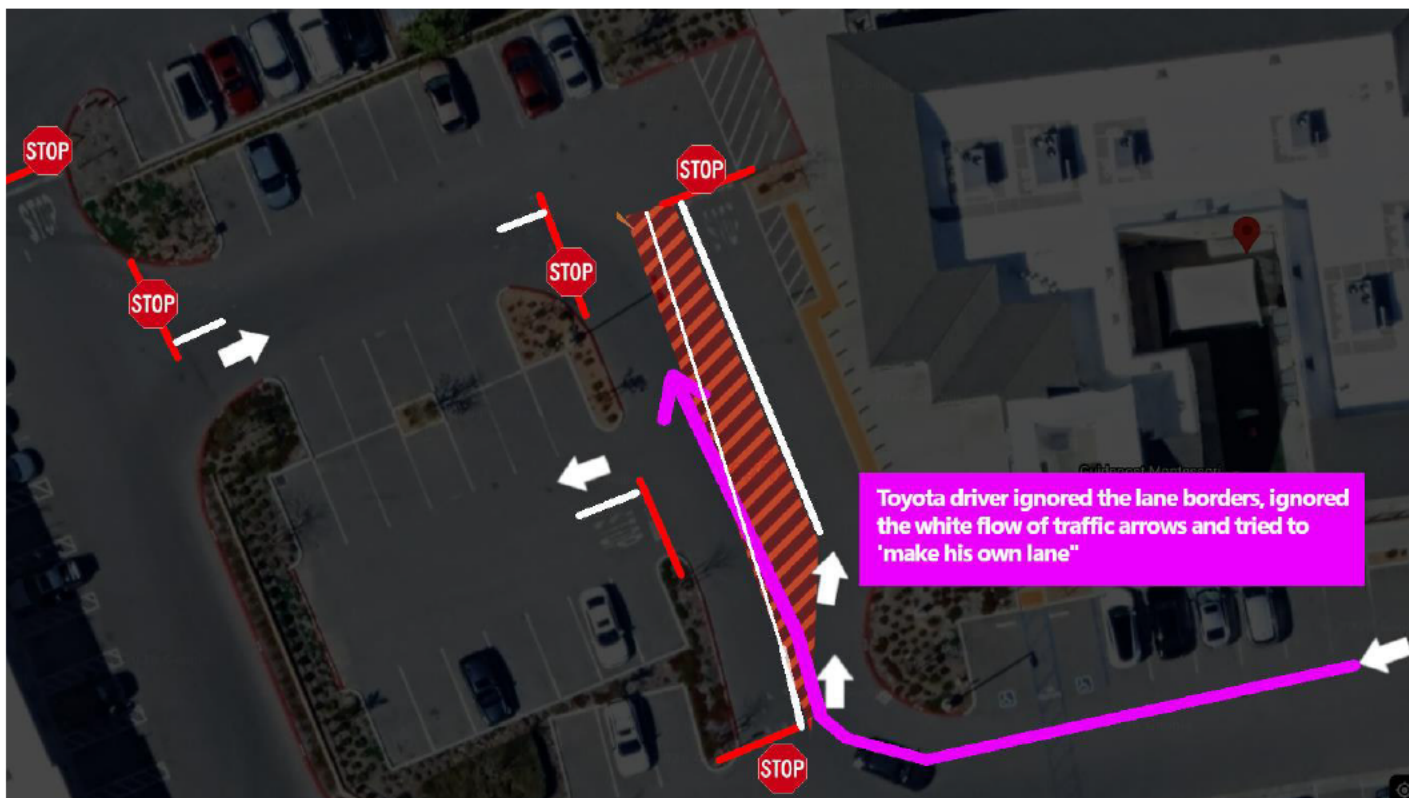
## COMPARATIVE ANALYSES OF THE ADJACENT PARKING LOT

The adjacent parking lot is comprised in exactly the same manner, as both were designed and built by Intertex properties. The white lines are painted on the ground and show lane borders and demarcation. They define the width and border of each lane. Just as with the school, arrows tell traffic which way to flow and which way to turn.

There are only two lanes, not three. The demarcation/lane borders are clearly defined. The Toyota instead did not maintain his heading into the right lane as directed by the arrows. He did not keep to the right. Instead he jerked the wheel, decided to not keep to the right and went straight into oncoming traffic **while having an entirely empty lane to his right complete with stop sign and no-passing lines.**

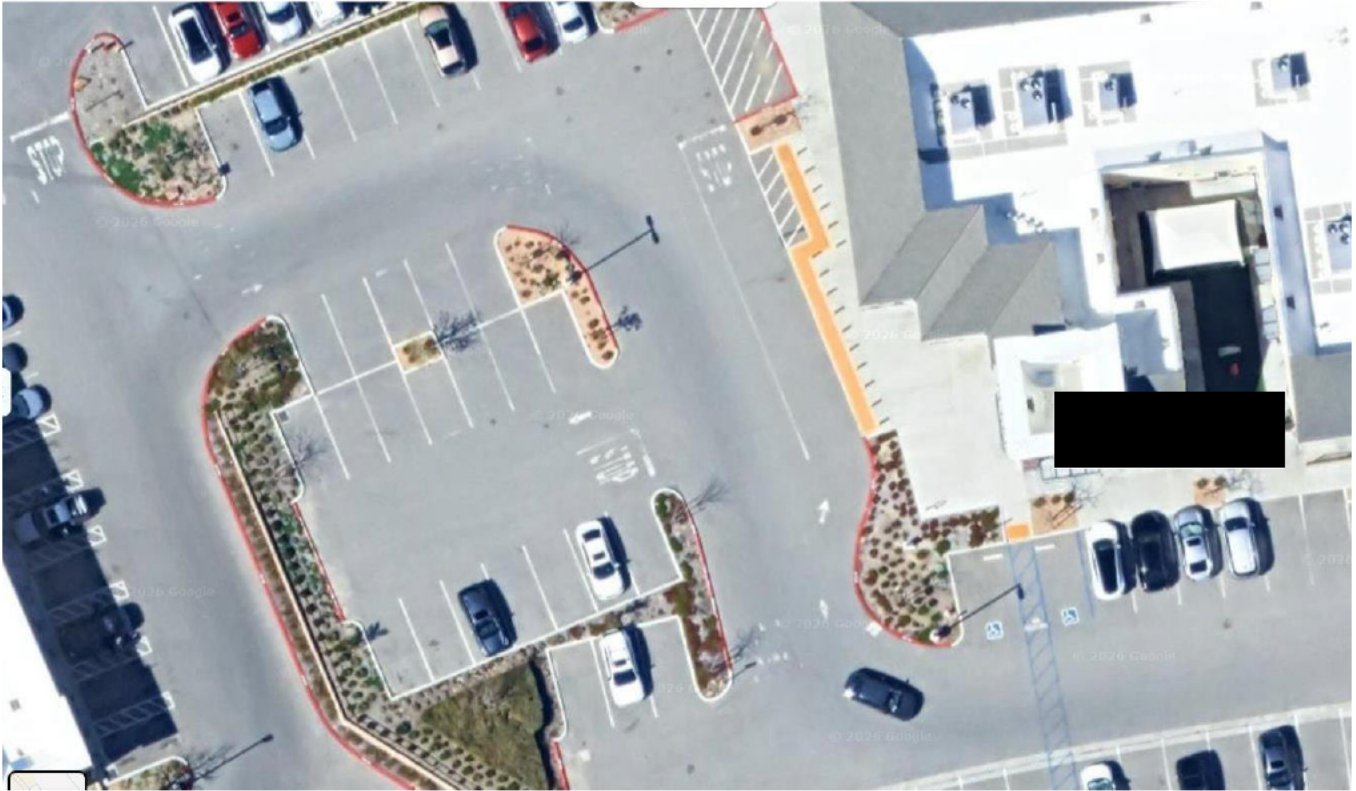
## **Turning The Corner Prior To Incident:**

The incident occurred when [REDACTED] Cybertruck was making a right turn from a stop sign. As you can see from this unedited map, there is a common path of travel due to the shape of the parking lot and it's barriers:

Color enhanced – yellow is normal vehicle travel, **blue** is improper vehicle travel from the Toyota who was required by law and by design to keep right.

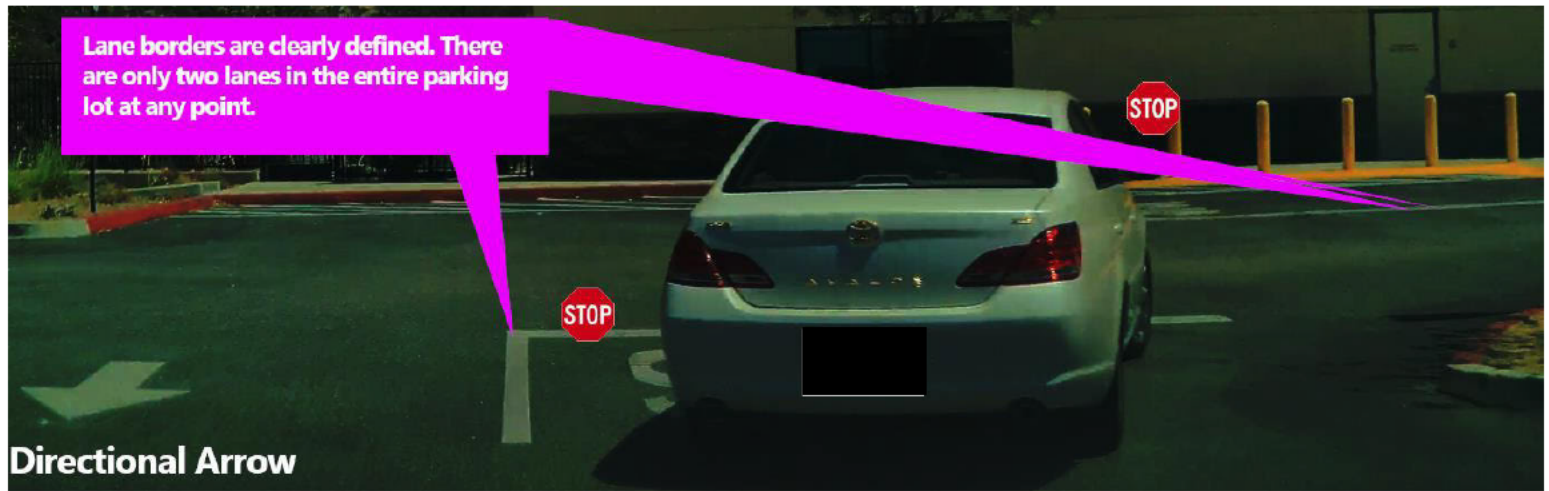
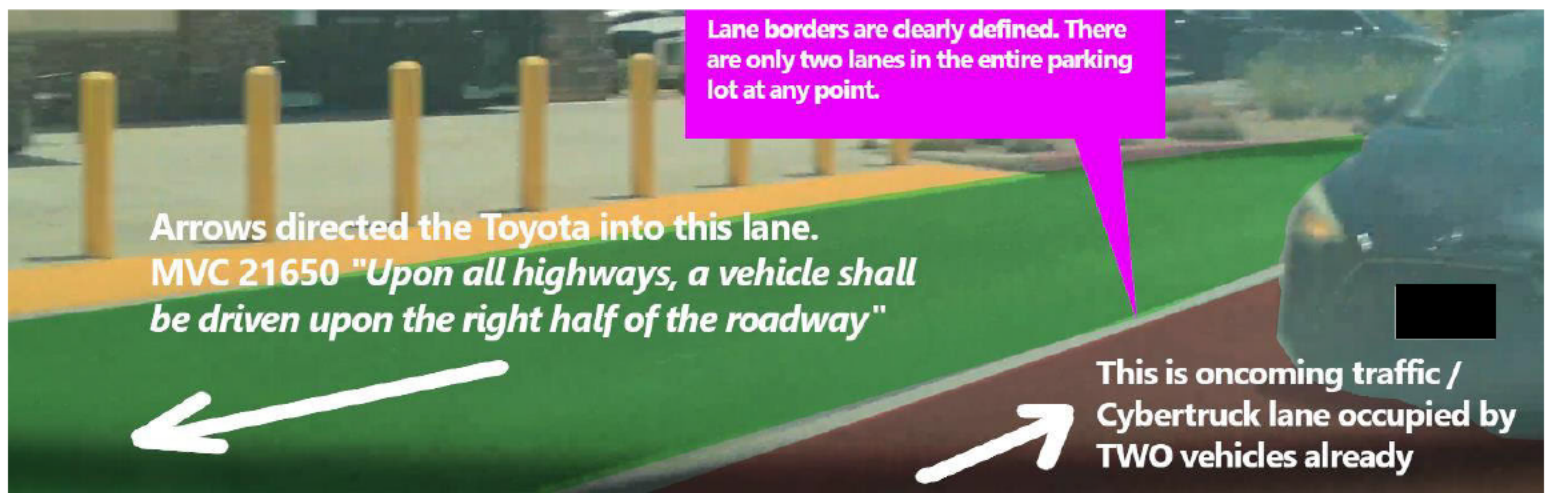
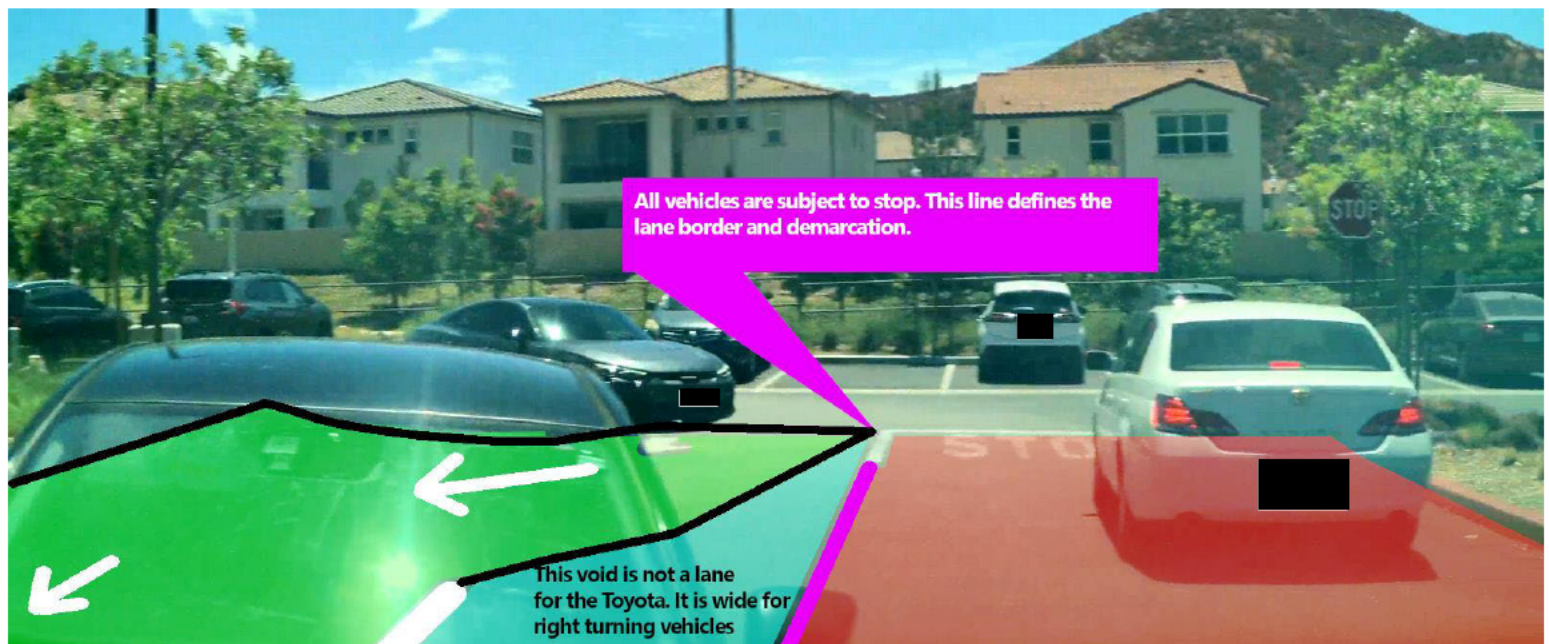
At all relevant times, there was another vehicle in front of the Cybertruck. As is clear from the footage, there are stop signs painted on the ground and directional arrows to control traffic flow and speed.

At the point of impact, once it's turn was complete the cybertruck was in it's lane with dead center pointing in the very middle of the lane.

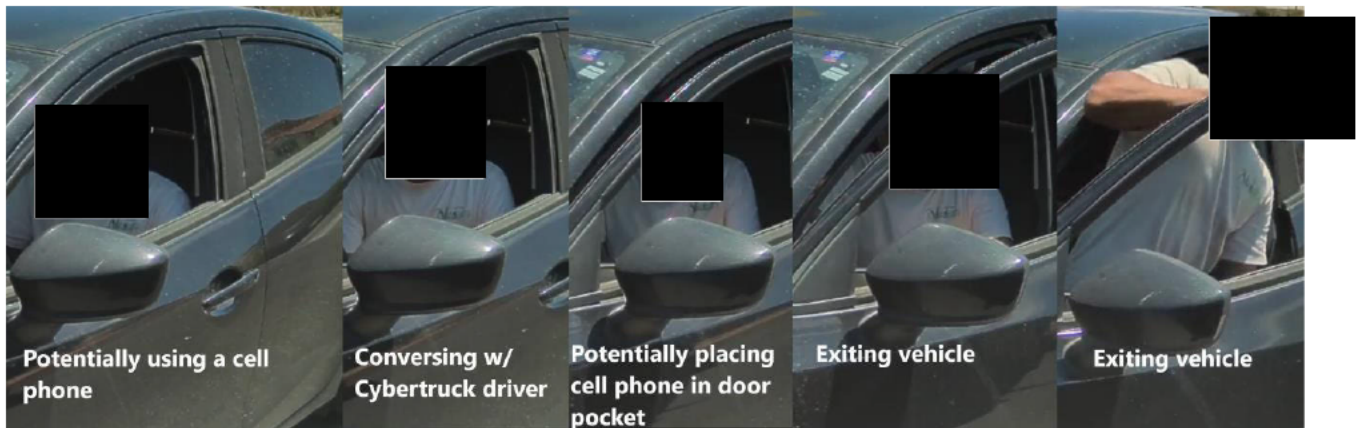
18. It should be noted, although it cannot be confirmed without further discovery... that the Toyota driver may have been on his cell phone at the time of the accident:
